**DEPARTMENT OF TRANSPORTATION**

Contract #: 04-0120F4Cty: SF/ALA Rte: 80 PM: 13.2/13.9File #: 1.28**WELDING INSPECTION REPORT****Resident Engineer:** Pursell, Gary**Address:** 333 Burma Road**City:** Oakland, CA 94607**Report No:** WIR-014509**Date Inspected:** 01-Jun-2010**Project Name:** SAS Superstructure**OSM Arrival Time:** 630**Prime Contractor:** American Bridge/Fluor Enterprises, a JV**OSM Departure Time:** 1500**Contractor:** American Bridge/Fluor Enterprises, a JV**Location:** Job Site

<b>CWI Name:</b>	Bernard Docena, Mike Johnson			<b>CWI Present:</b>	<b>Yes</b>	<b>No</b>
<b>Inspected CWI report:</b>	<b>Yes</b>	<b>No</b>	<b>N/A</b>	<b>Rod Oven in Use:</b>	<b>Yes</b>	<b>No</b> <b>N/A</b>
<b>Electrode to specification:</b>	<b>Yes</b>	<b>No</b>	<b>N/A</b>	<b>Weld Procedures Followed:</b>	<b>Yes</b>	<b>No</b> <b>N/A</b>
<b>Qualified Welders:</b>	<b>Yes</b>	<b>No</b>	<b>N/A</b>	<b>Verified Joint Fit-up:</b>	<b>Yes</b>	<b>No</b> <b>N/A</b>
<b>Approved Drawings:</b>	<b>Yes</b>	<b>No</b>	<b>N/A</b>	<b>Approved WPS:</b>	<b>Yes</b>	<b>No</b> <b>N/A</b>
				<b>Delayed / Cancelled:</b>	<b>Yes</b>	<b>No</b> <b>N/A</b>
<b>Bridge No:</b>	34-0006			<b>Component:</b>	SAS OBG

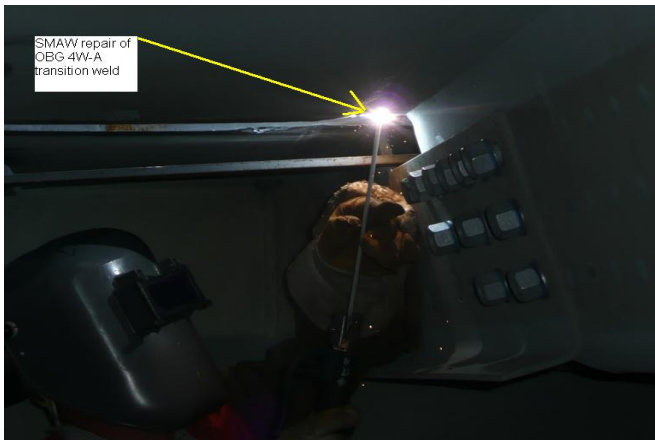
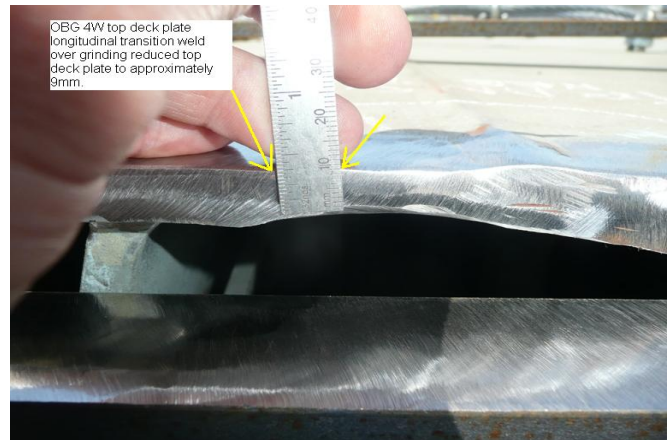
Upon the arrival of the QA Inspector at the above identified location it was observed the OBG identified as 5W was pushed in to within 400mm of the OBG 4W. The QA Inspector performed a preliminary inspection of the condition of the beveled edges and grinding which had been performed on the transition welds in the top deck plate in the am. The QA Inspector randomly observed the longitudinal transition weld on the north end of the deck appeared to have been over ground. The QA Inspector noted the 14mm top deck plate appeared to had been reduced at the transition by over grinding to approximately 9mm near the edge of the bevel. The QA Inspector informed the ABF Welding Superintendent Dan Ieraci (see summary of conversations)

The QA Inspector randomly observed the ABF welder begin preheating the over ground area described above. Once the minimum required preheat temperature had been reached, the QA Inspector randomly observed the ABF welder begin the shielded metal arc welding (SMAW) repair. The QA Inspector randomly observed the ABF welder utilizing 1/8" E7018 low hydrogen electrodes with 135Amps. The QA Inspector noted the SMAW parameters appeared to be in general compliance with WPS-D1.5-1000-R2, the QA Inspector noted the SE QC Inspector Mike Johnson was present at the time of the welding. The QA Inspector noted approximately 4 SMAW passes were deposited over the ground out area. After the welding was completed the QA Inspector randomly observed the ABF welder perform grinding tasks and grind and blend the area flush with the parent base metal. The QC Inspector performed magnetic particle testing of the repair and informed the QA Inspector no relevant indications were located at the time of the testing. The QA Inspector performed dimensional measurements of the repaired area and noted the base metal appeared to have been restored to the original nominal thickness of 14mm.

The QA Inspector informed the Mr. Ieraci of the area of the transition which appeared to have been reduced to 9mm. Mr. Ieraci informed the QA Inspector he was aware of the over ground area and expressed displeasure with the ABF representative who performed the grinding. Mr. Ieraci informed the QA Inspector he has already instructed the ABF welder Rick Clayborn to correct the over ground area by welding.
